Arlington Housing Authority
Building Envelope Repairs, Window Replacement, Phase 1
Winslow Towers 667-3, Elderly Housing
Schematic Report and Recommendations

Re: Winslow Towers Condition Assessment - DRAFT
WJE No. 2017.6855

Wiss, Janney, Elstner Associates, Inc. (WJE) completed a facade condition assessment and performed diagnostic water penetration testing at the Arlington Housing Authority (AHA) property Winslow Towers located at 4 Winslow Street in Arlington, Massachusetts. This letter is intended to serve as a summary of our observations and provide recommendations for short and long-term repairs.

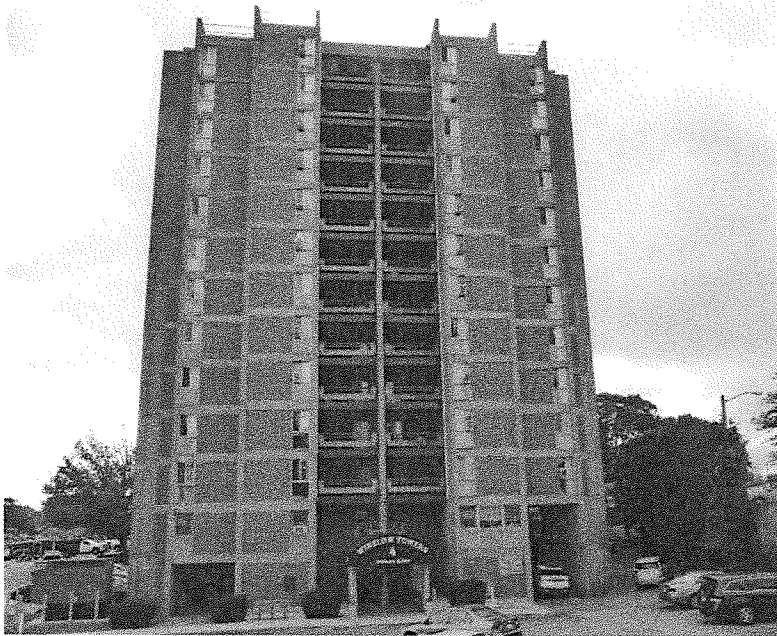
Figure 1. Winslow Towers, west facade

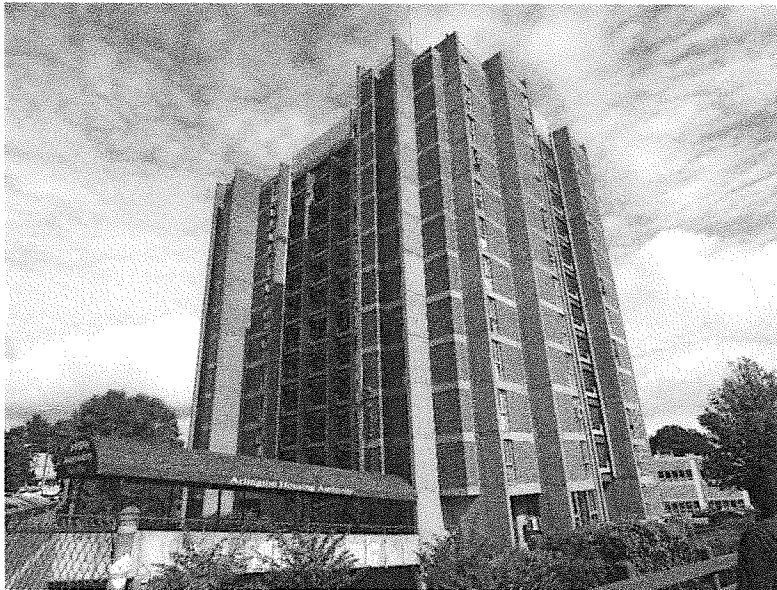
Figure 2. Southeast corner with pedestrian bridge at the south facade

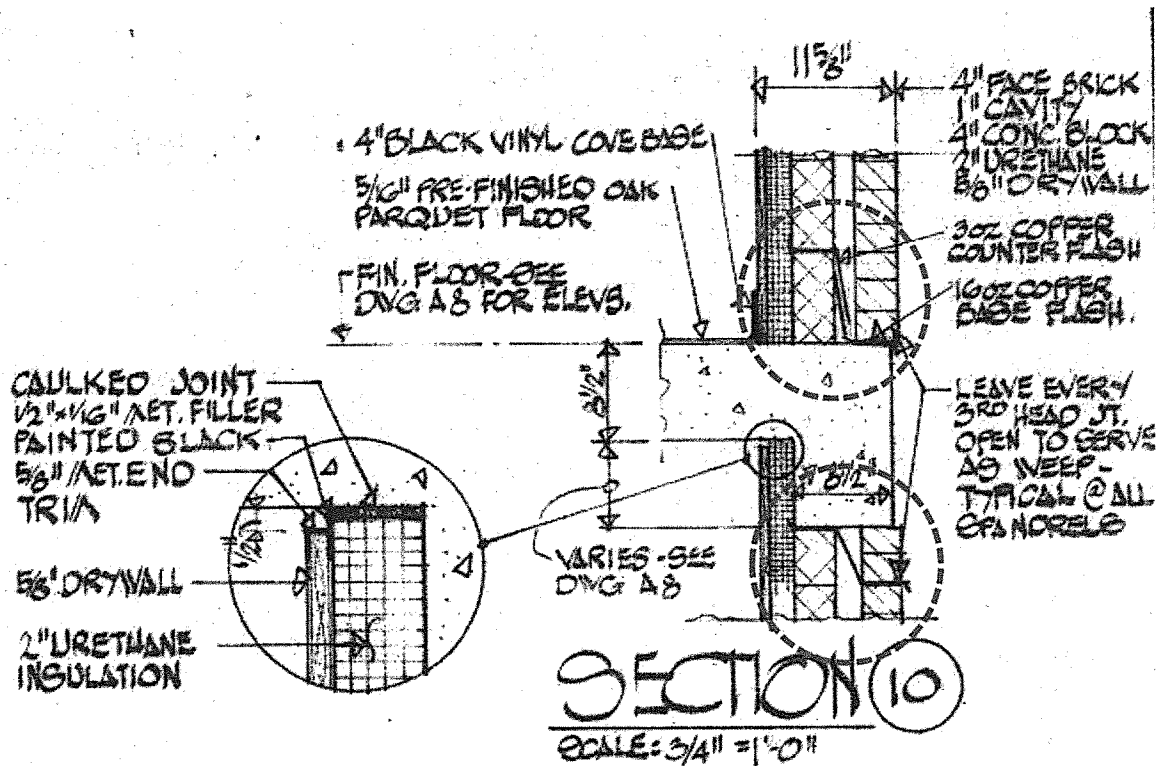
- Typical cavity wall construction spans between floor slab and perimeter beam soffit, and includes face brick, a 1-inch wide cavity, 4-inch thick concrete masonry block (CMU), 2-inches of rigid insulation, and 5/8-inch thick gypsum wallboard' (Figure 3 and Figure 4).

Figure 3. Typical section detail at floor line and concrete perimeter beam soffit from original construction documents, prepared by Robert Charles Associates, Inc., dated December 11, 1967. Note locations of through wall flashings (circled).

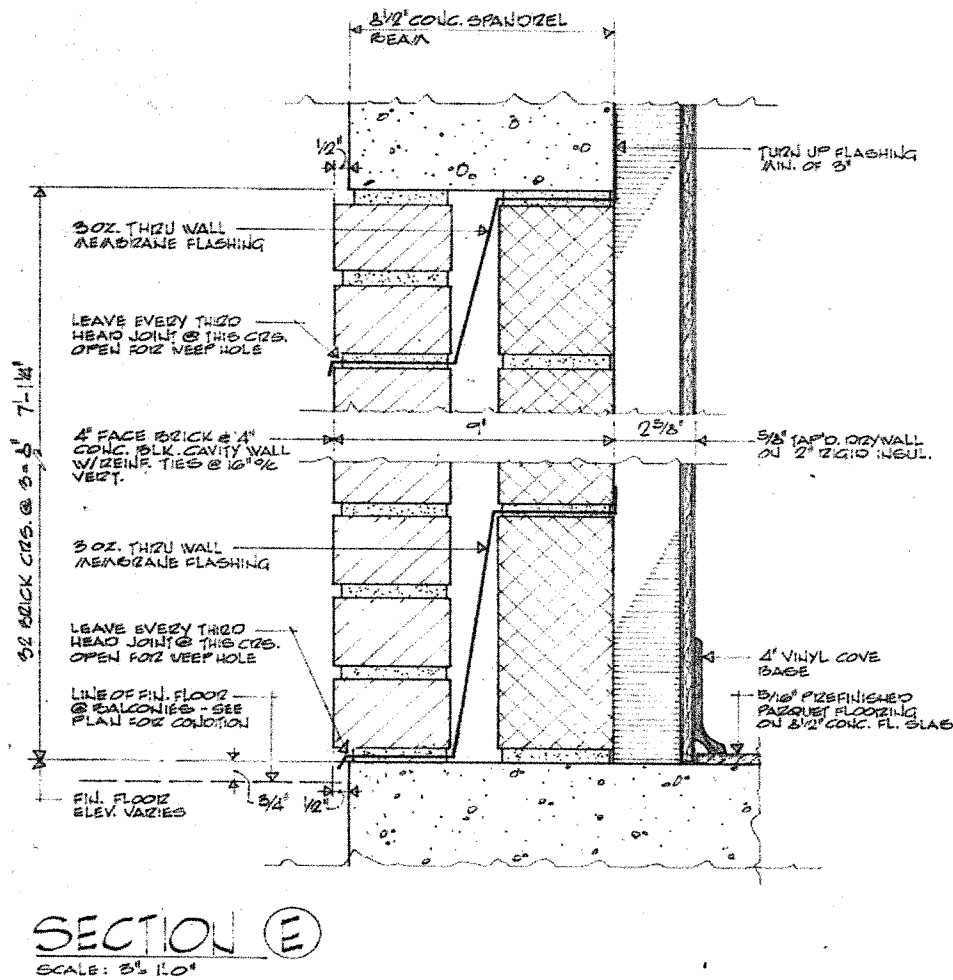
Figure 4. Typical wall section from original construction documents, prepared by Robert Charles Associates, Inc., dated December 11, 1967. Note locations of through wall flashings.

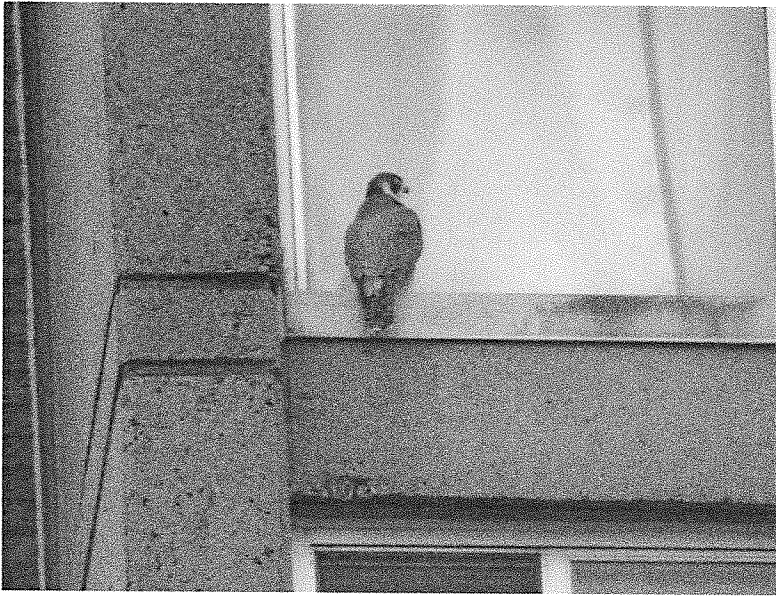
- A peregrine falcon was spotted at the west facade during the binocular survey performed by WJE (Figure 52).

Figure 52. Peregrine falcon perched on west facade

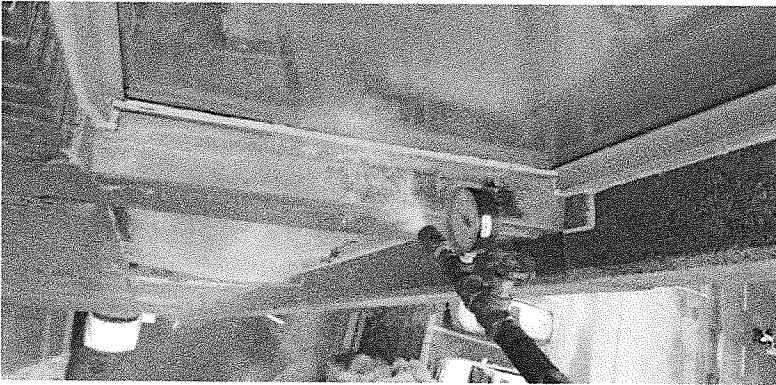
Diagnostic handheld spray nozzle testing began with the first test at the west facade bedroom window of Unit 1102. The window directly below in Unit 1002 was covered with plastic to direct water away from this window assembly. The testing was focused initially on the window sill, window sill sealant, and sill flashing (Figure 53 and Figure 54). The building water pressure fluctuated throughout the testing, test pressure was controlled using the valve to keep pressure as close to 20 psi as possible. Testing was performed by spraying water along the window sill, moving the nozzle at a speed of 1 linear foot (LF) per minute. The total test time was approximately 20 minutes. No water infiltration was observed during this test.

Figure 53. Testing with spray nozzle at window, west facade, eleventh floor

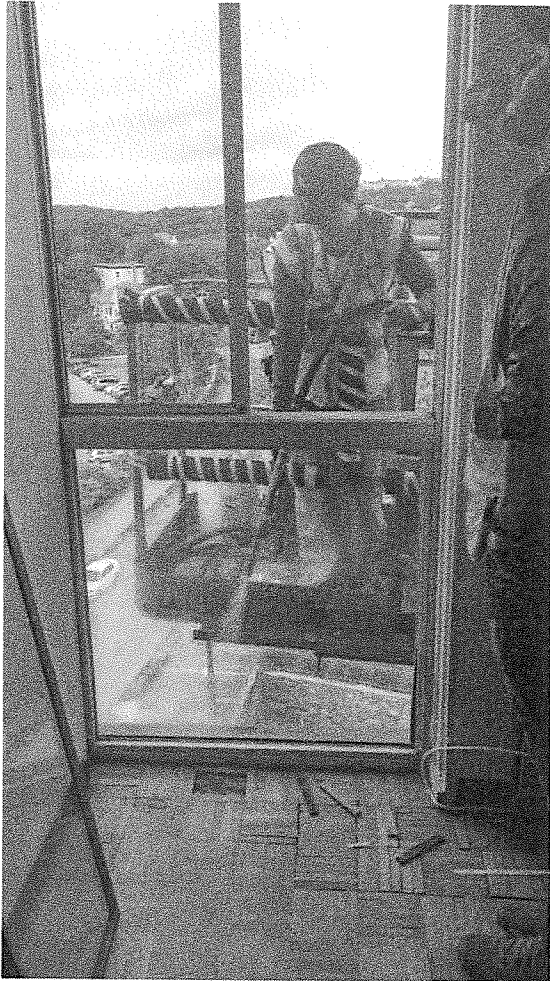
Figure 54. Testing with spray nozzle at window, west facade, eleventh floor

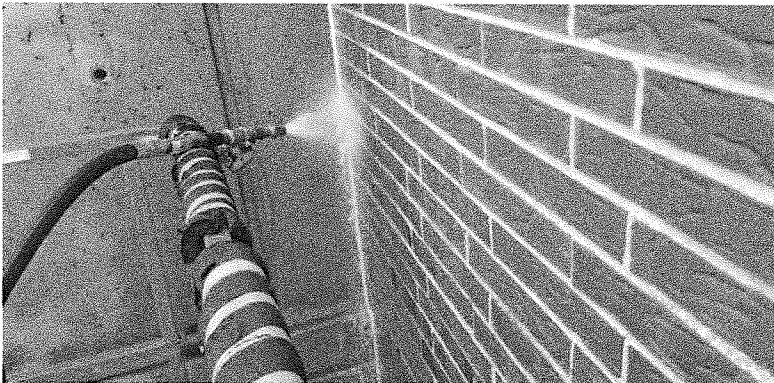
Testing was subsequently performed at the vertical sealant joint along the interface between the concrete wall and the masonry infill wall at the building corner. The third test started at this vertical corner sealant joint, starting at the soffit of the twelfth-floor concrete perimeter beam (immediately above the eleventh-floor window level). During this test it was reported that there was water infiltration at Unit 902, two floors below. Testing was temporarily stopped. Water infiltration was observed at the ceiling adjacent to the bedroom window in Unit 902 (Figure 58 and Figure 59). Testing restarted at the vertical sealant joint. Testing was performed by spraying water up the vertical sealant joint, moving the nozzle at a speed of 1 LF/minute (Figure 60). After 15 minutes, water was observed at the ceiling, at a concrete crack approximately two feet from the exterior wall (Figure 61). As the test continued, the water infiltration moved further into the interior along the concrete crack (Figure 62). The test was concluded after approximately 30 minutes. Water continued to enter at the ceiling even after the water was shut off.

Figure 60. Water sprayed through spray nozzle at vertical corner sealant joint at eleventh floor

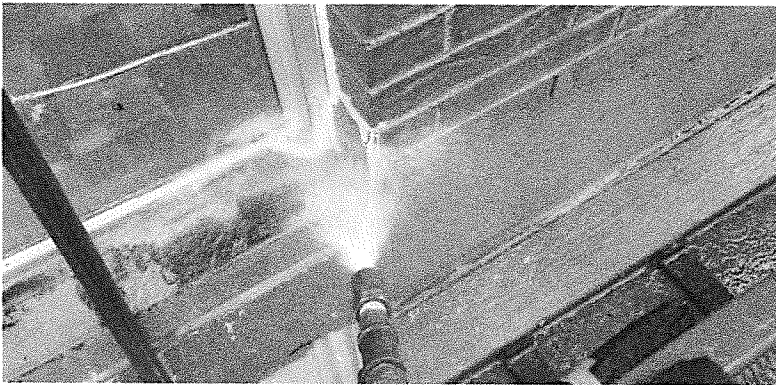
Subsequent testing at the fourth location was at the facade corner at the living room. Initial testing at this location focused on the floor line and the window sill. Testing was performed by spraying water along the floor line at the interface of the concrete perimeter beam and brick infill above, moving the nozzle at a speed of 1 LF/minute towards the window (Figure 63). Testing ended at the window sill flashing when water was observed at the interior at the floor (Figure 64). Parquet flooring was removed to better observe the water infiltration. Water continued to enter below the living room window even after the water was shut off. Voids in the sealant at the window sill were noted during the testing (Figure 65 and Figure 66). Additional testing (Test No. 5 in Table 1) at the concrete perimeter beam flashing (below the beam) in the same area did not result in any additional water infiltration (Figure 67).

Figure 63. Water sprayed through spray nozzle at concrete floor line and brick infill on exterior of living room window of unit 1102

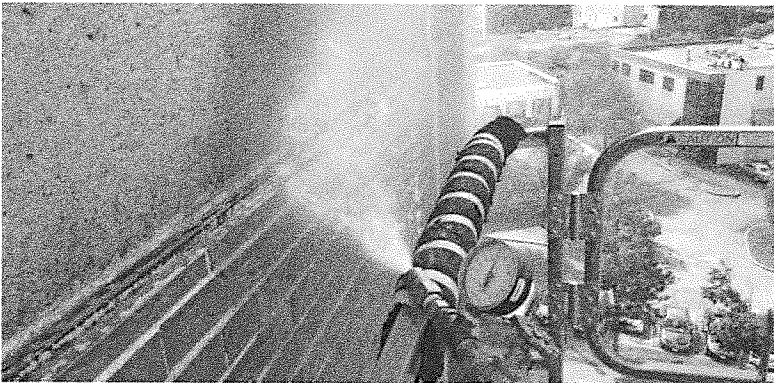
Figure 67. Water sprayed through spray nozzle at concrete perimeter beam soffit flashing on exterior wall outside the living room of unit 1102
